Swanage Railway Trust
563 Locomotive Group
Station House
Swanage
Dorset
BH19 1HB

563LG, T3 Times – November 2021

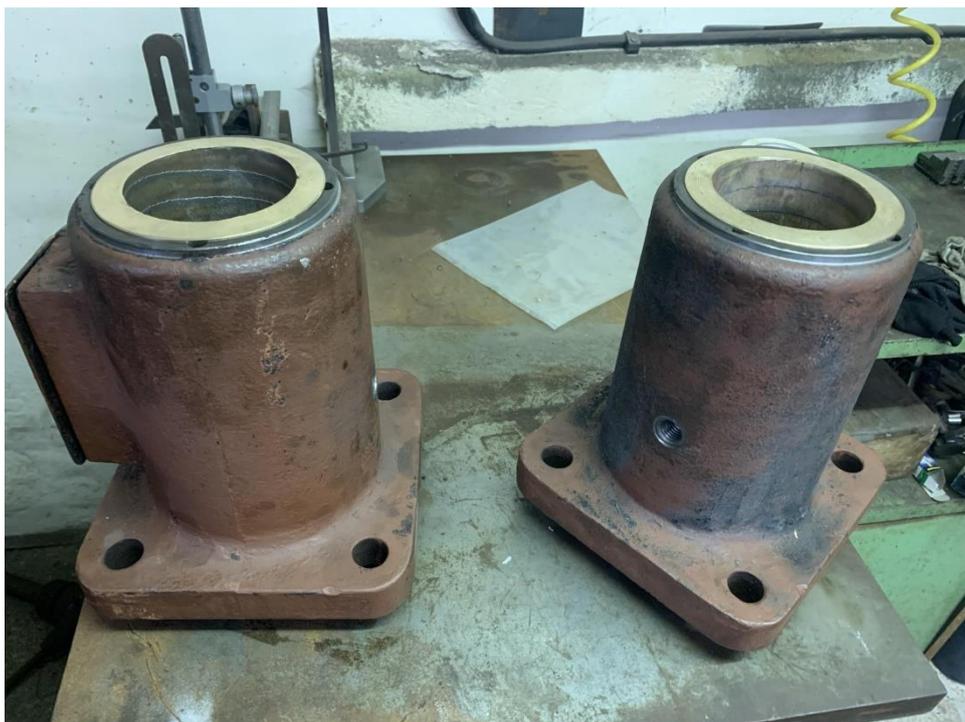
The machined cannon boxes with new bronze liners that guide the valve rods.

The team at the Flour Mill have been hard at work, as always, since our last T3 Times. Work has been focusing on the loco chassis and valve gear ahead of eventual re-wheeling. The cannon boxes that the valve rods go through have been machined, boring them out and putting in bronze liners, ready for reassembly of the valve gear. The brake gear has been re-bushed to remove the slack in the assembly. Ahead of re-wheeling, the team have spent about a week on filling, painting and rubbing down the frames. Likewise, they are painting the wheels as this is much easier to do while they are out of the frames - they are hard enough to paint anyway with the enormous surface area of all the spokes, especially with all the irregular cast surfaces. The Flour Mill has machined the new steel horn ties which are fitted in place, although of course, they will have to be removed to put the wheels in.

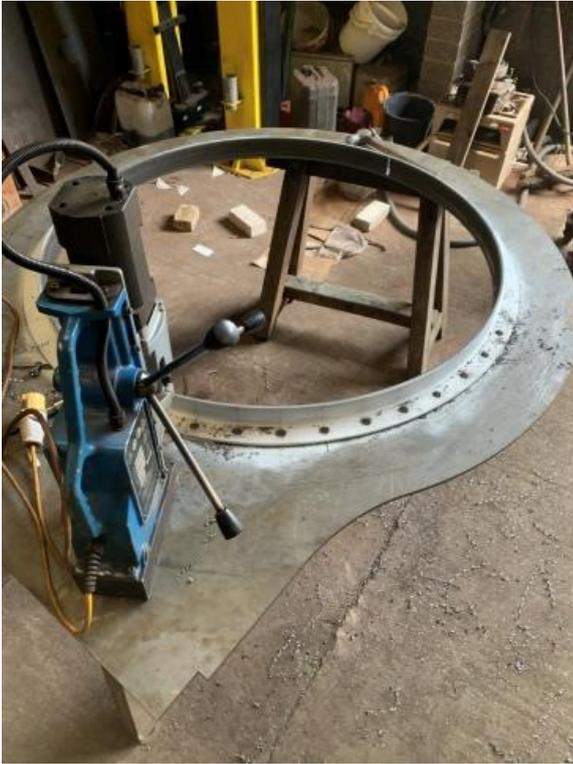
Smokebox

Following a call for sponsors a few months ago, we are delighted to announce that a supporter has come forward and donated the cost of replacing this. The smokebox will be re-made to the original specifications, including the use of flush rivets. We offer our grateful thanks for this most generous donation.

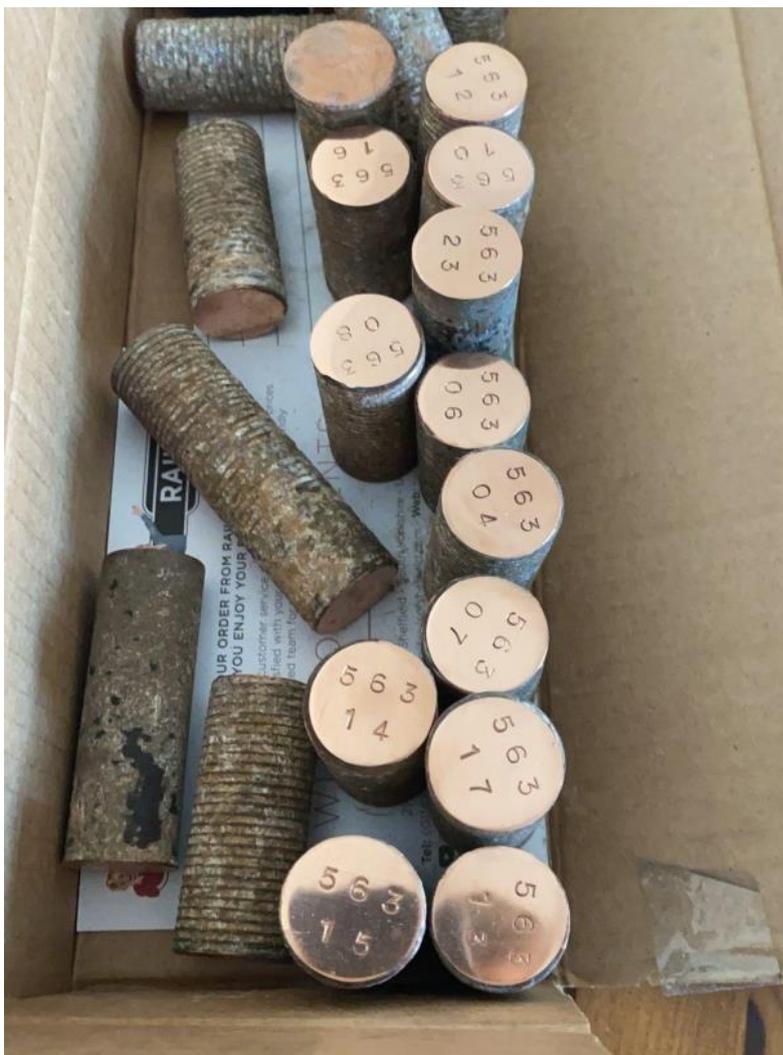
Stays

One of our supporters, Martin Sheret, has done a sterling effort in turning and stamping the original stays removed from 563's firebox. Each Stay is individually numbered and is your chance to get your hands on a unique piece of our T3! These are offered to supporters donating over £100 after the first 12 months, or an equivalent lump sum. We have now sent these out to all of the relevant supporters, although we still have a limited number of these available on a first-come-first-served basis. Once they're gone they're gone!
